## Tube Mill DC Drive Upgrade Project

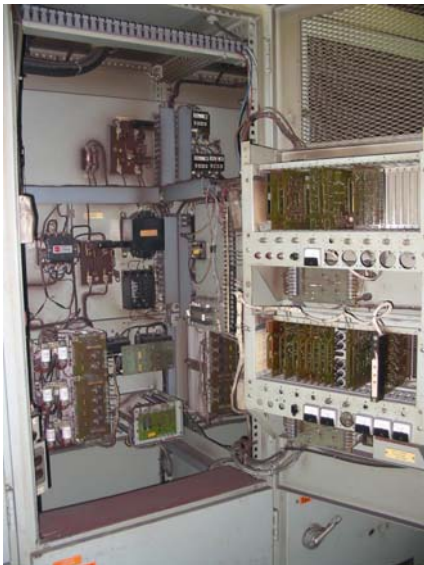
Figure 2 - Existing Westinghouse Regulator

This portion of the project involved the removal of the existing Westinghouse regulator circuits (see Figure 2), while keeping the drive cabinet, contactors, motor feeds and 3,000-hp motors on both sections. Each section was then retrofit with an Avtron AFM firing module, which controls the existing equipment, fires the SCR bridge and has full communication capability with the other Avtron drives (see Figure 3).
